Naval Facilities Engineering Command

Abstract of an Accident

01-03

Type of Work: Removing Concrete Support Forms from beneath Pier.

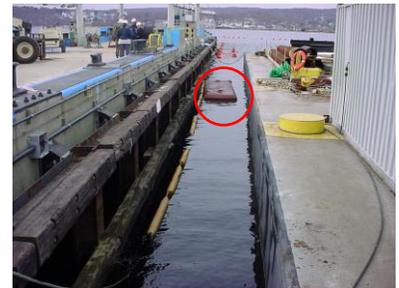
Outer float at accident site.

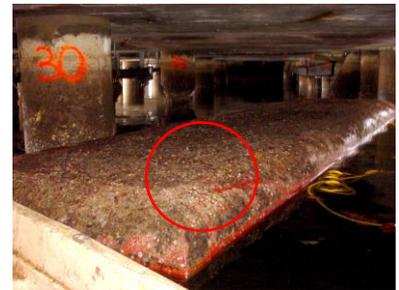
- ◆ Instability of material float.
- ◆ Employee walking on loaded unstable material float.

- ◆ Loading of steel beams off center on material float.
- ◆ Lack of job/site specific Activity Hazard Analysis (AHA).
- ◆ Lack of stability calculations for material float.
- ◆ Failure to follow work practices or procedures for loading steel beams on material barge.

Inner capsized material float.

- ◆ AHA must be site specific for each definable feature of work.
- ◆ AHA must address all control measures to be followed.
- ◆ Employees must follow set work procedures identified.

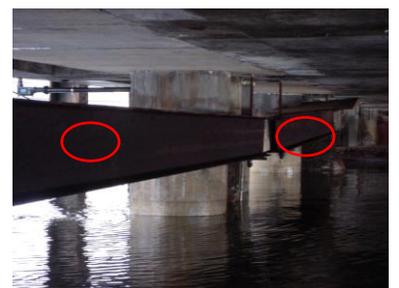
Concrete support steel beams ready for retrieval.

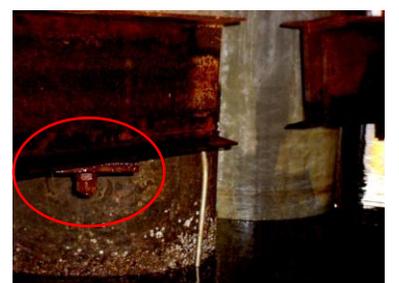
Close up of steel beams

with lifting washer and nut.
